SUBJECT: ON-SCENE COORDINATOR'S REPORT - Removal Action at  
Morris Paint and Varnish Site, East St. Louis,  
Illinois (Site ID# HP)

**ON-SCENE COORDINATOR'S REPORT  
CERCLA REMOVAL ACTION**

**MORRIS PAINT AND VARNISH COMPANY  
EAST ST. LOUIS, ILLINOIS  
SITE ID# HD**

**DELIVERY ORDER NO. 7460-05-137  
REMOVAL DATES: MARCH 16, 1990 TO JUNE 6, 1990**

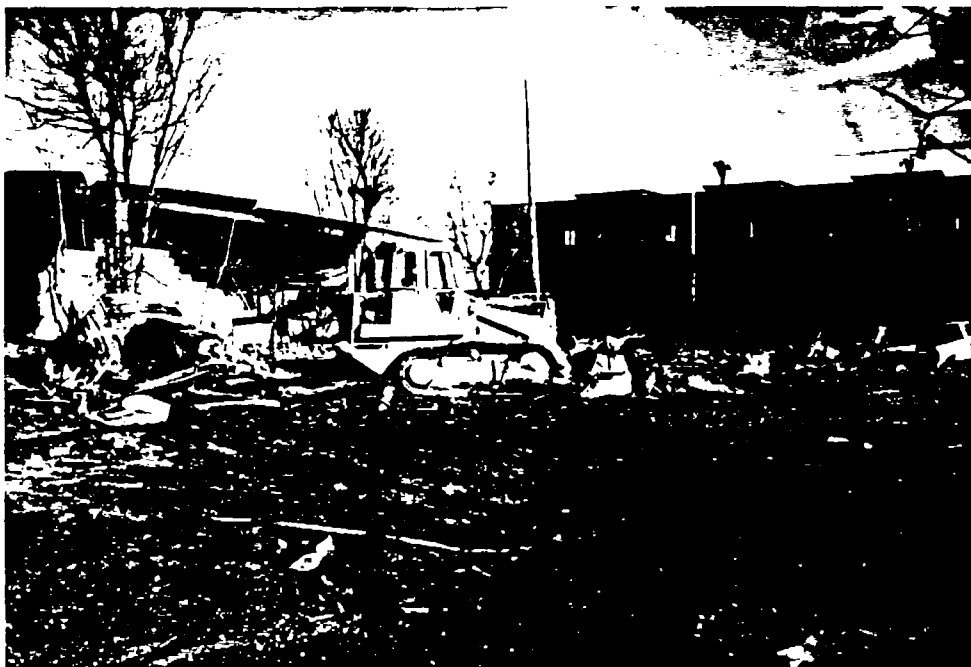
PHOTO: 2  
 SITE NAME: MORRIS PAINT, EAST ST. LOUIS, ILLINOIS  
 DESCRIPTION: FRONT END LOADER MOVING METAL SCRAP  
 AND DEBRIS ON SOUTHERN CORNER OF SITE  
 DATE/TIME: 03-17-90/1400  
 PHOTOGRAPHER: N. KUMARANAYAGAM *NK*  
 FILM: 35MM, ISO 200

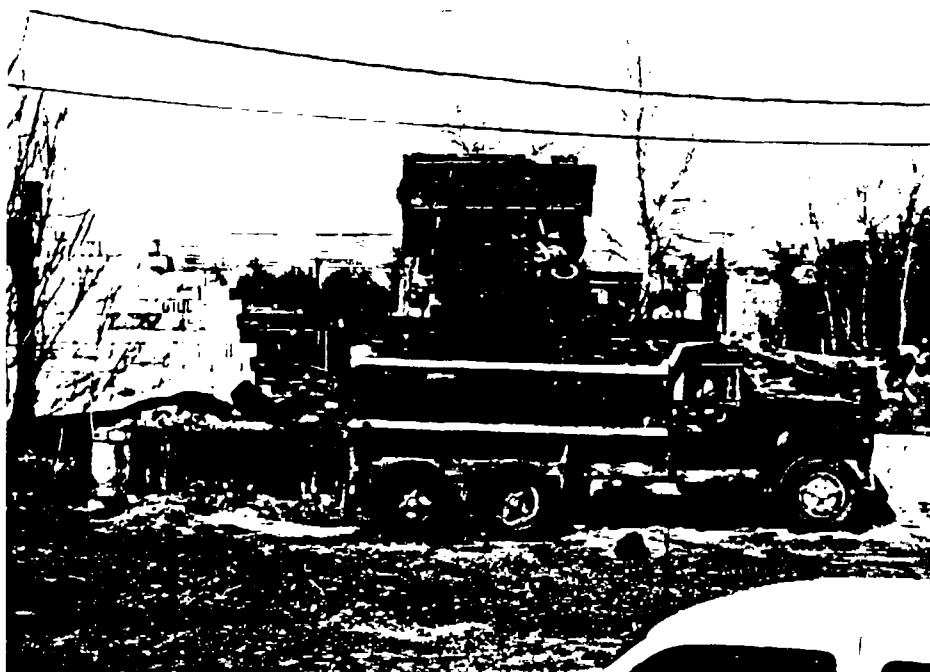
PHOTO: 8  
 SITE NAME: MORRIS PAINT, EAST ST. LOUIS, ILLINOIS  
 DESCRIPTION: FRONT END LOADER LOADING METAL SCRAP ON TO  
 GIBSON'S TRUCK  
 DATE/TIME: 03-18-90/1130  
 PHOTOGRAPHER: N. KUMARANAYAGAM *NK*  
 FILM: 35MM, ISO 200

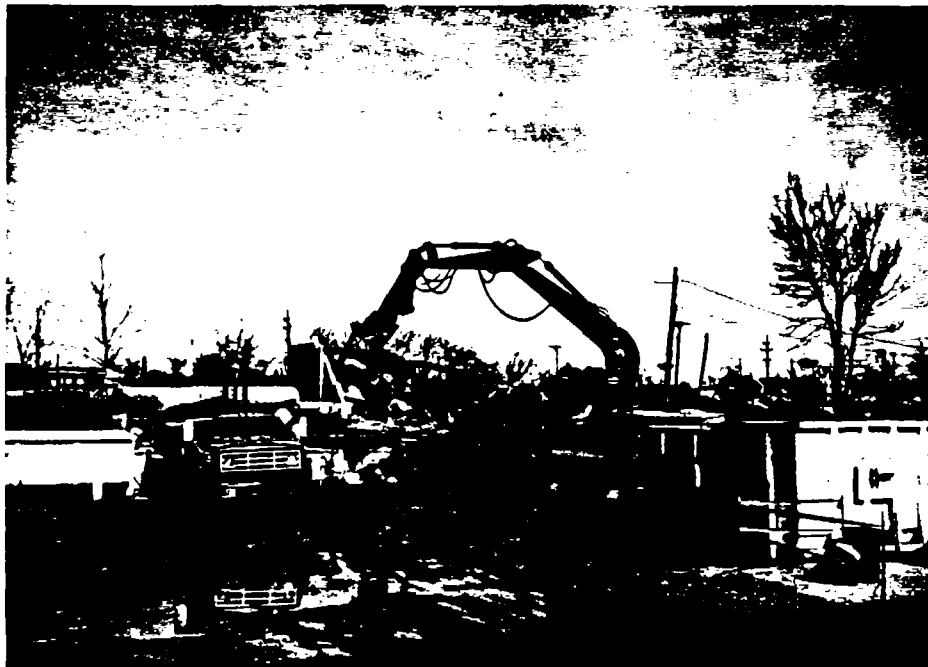
PHOTO: 10  
 SITE NAME: MORRIS PAINT, EAST ST. LOUIS, ILLINOIS  
 DESCRIPTION: TRACKHOE WITH SHEARS LOADING METAL SCRAP ON TO  
 GIBSON'S TRUCK  
 DATE/TIME: 03-28-90/1000  
 PHOTOGRAPHER: N. KUMARANAYAGAM *NK*  
 FILM: 35MM, ISO 200

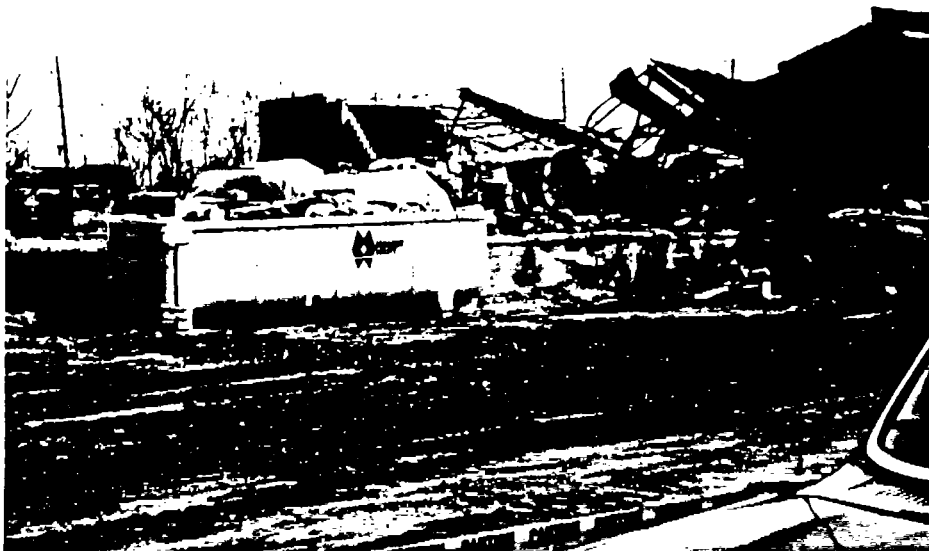
PHOTO: 13  
 SITE NAME: MORRIS PAINT, EAST ST. LOUIS, ILLINOIS  
 DESCRIPTION: ROLLOFF BOX CONTAINING CRUSHED DRUMS AND TANKS  
 DATE/TIME: 03-25-90/9010  
 PHOTOGRAPHER: N. KUMARANAYAGAM *NK*  
 FILM: 35MM, ISO 200

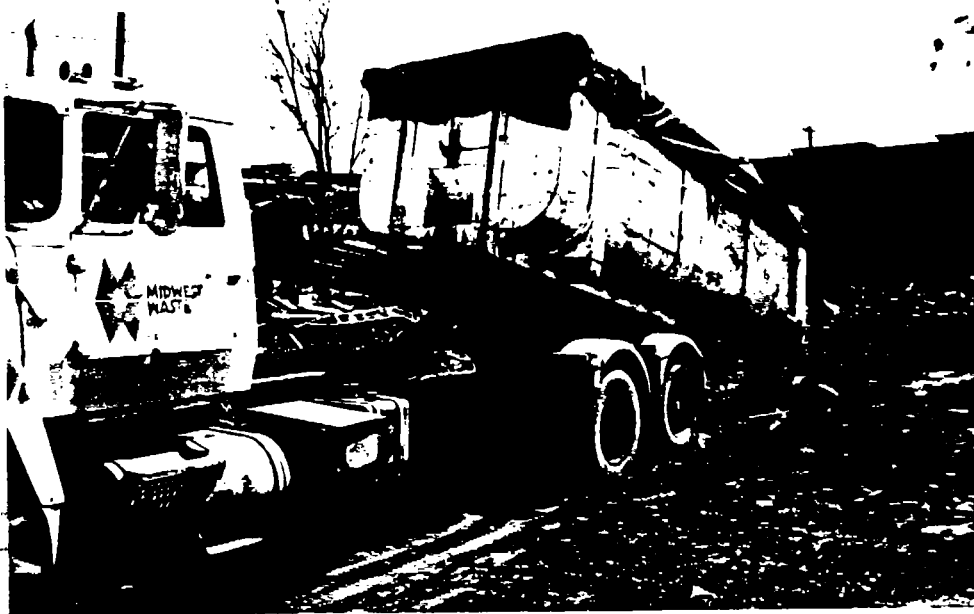
PHOTO: 14  
 SITE NAME: MORRIS PAINT, EAST ST. LOUIS, ILLINOIS  
 DESCRIPTION: MIDWEST WASTE DELIVERING EMPTY ROLLOFF BOX  
 DATE/TIME: 03-22-90/1230  
 PHOTOGRAPHER: N. KUMARANAYAGAM *NK*  
 FILM: 35MM, ISO 200

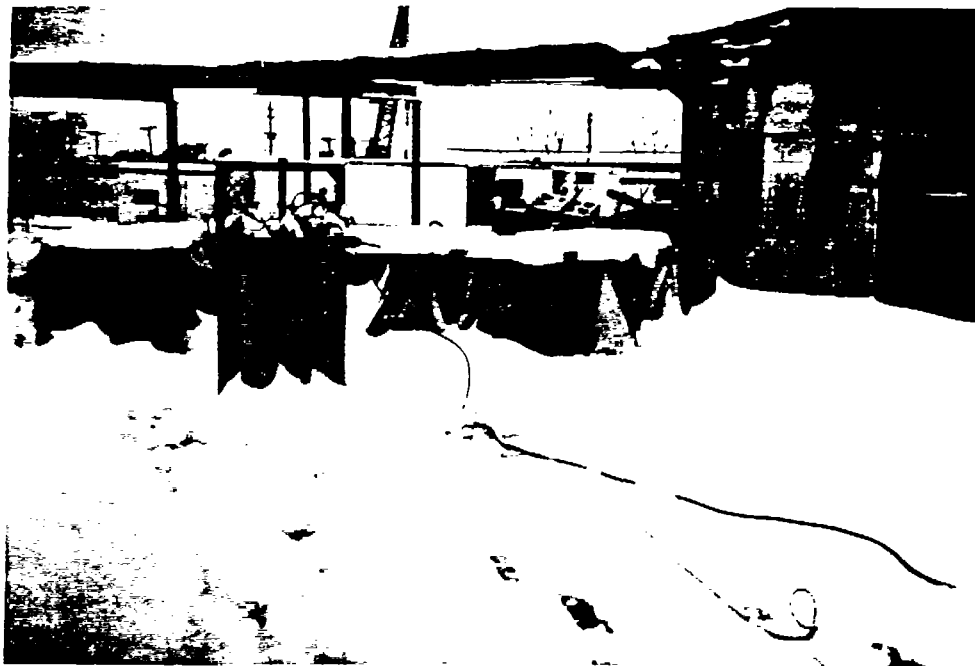
PHOTO: 15  
 SITE NAME: MORRIS PAINT, EAST ST. LOUIS, ILLINOIS  
 DESCRIPTION: SITE AFTER SNOWSTORM, DRUMS HAVE BEEN COVERED  
 WITH VISQUEEN  
 DATE/TIME: 03-24-90/1000  
 PHOTOGRAPHER: N. KUMARANAYAGAM *NK*  
 FILM: 35MM, ISO 200

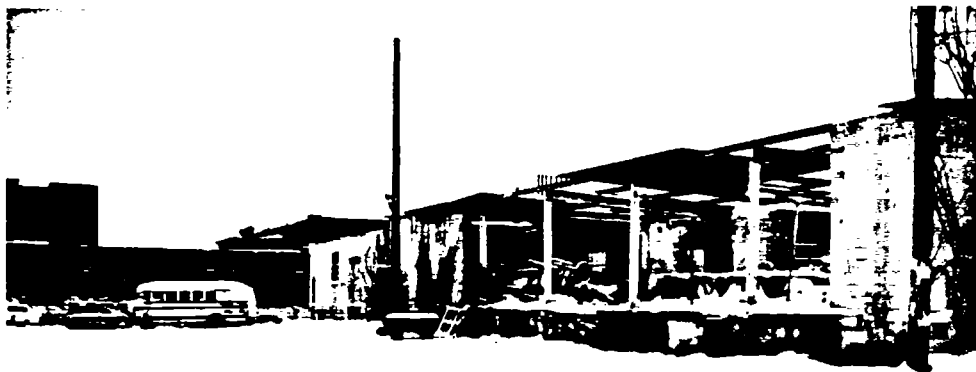
PHOTO: 16  
 SITE NAME: MORRIS PAINT, EAST ST. LOUIS, ILLINOIS  
 DESCRIPTION: SITE AFTER SNOWSTORM  
 DATE/TIME: 03-24-90/1030  
 PHOTOGRAPHER: N. KUMARANAYAGAM *NK*  
 FILM: 35MM, ISO 200

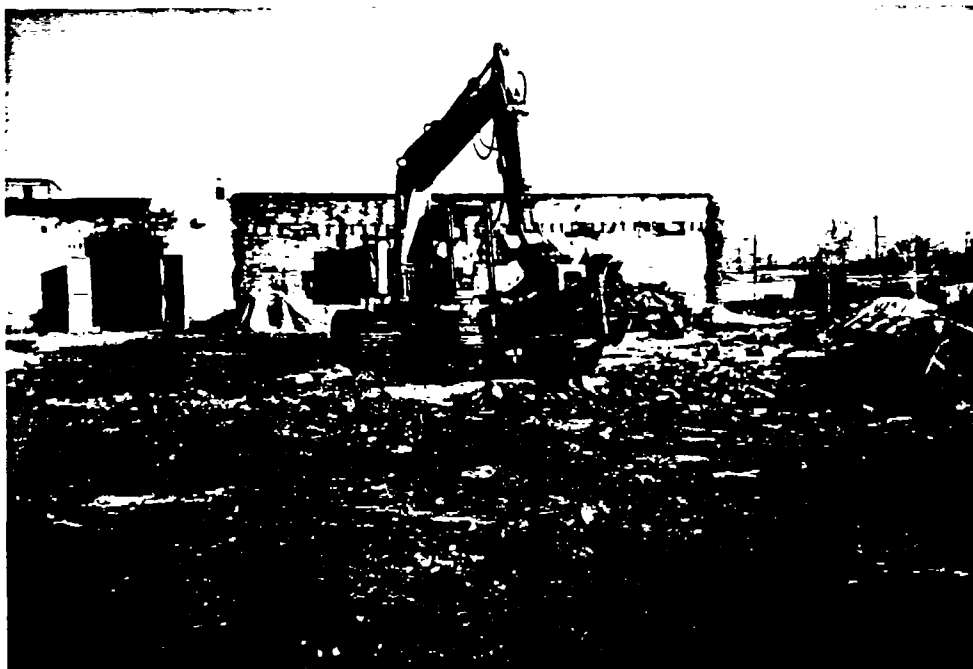
PHOTO: 20  
 SITE NAME: MORRIS PAINT, EAST ST. LOUIS, ILLINOIS  
 DESCRIPTION: TRACKHOE WITH SHEARS CUTTING UP TANKS  
 DATE/TIME: 04-05-90/8045  
 PHOTOGRAPHER: N. KUMARANAYAGAM *NK*  
 FILM: 35MM, ISO 200

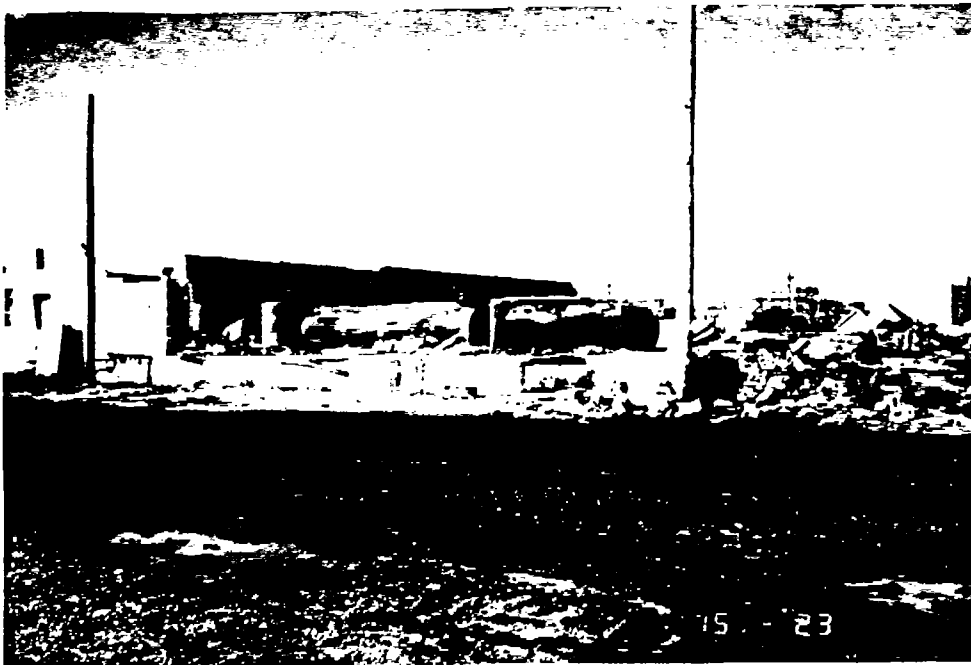
PHOTO: 21  
 SITE NAME: MORRIS PAINT, EAST ST. LOUIS, ILLINOIS  
 DESCRIPTION: EXCAVATED UNDERGROUND TANKS  
 DATE/TIME: 04-06-90/1523  
 PHOTOGRAPHER: N. KUMARANAYAGAM *NK*  
 FILM: 35MM, ISO 200

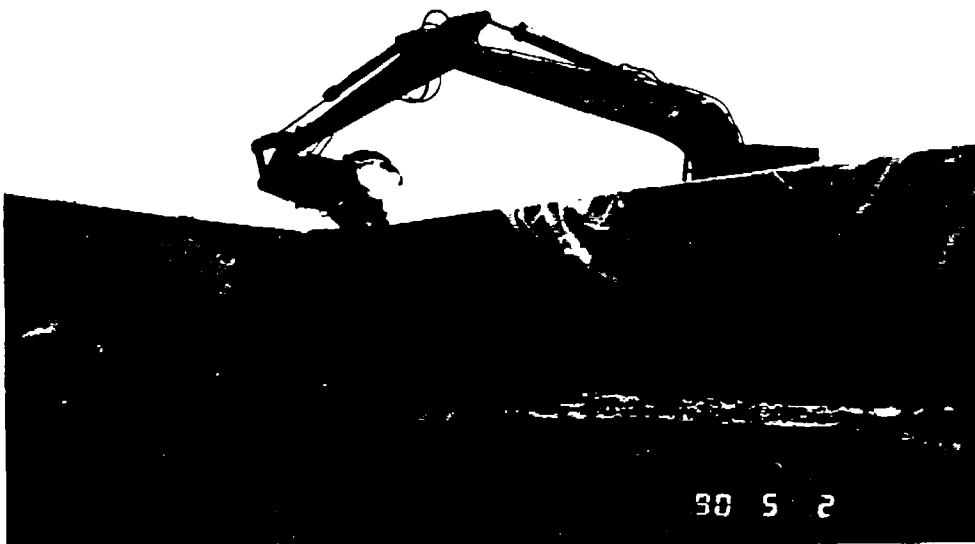
PHOTO: 23  
 SITE NAME: MORRIS PAINT, EAST ST. LOUIS, ILLINOIS  
 DESCRIPTION: TRACKHOE WITH DRUM GRAPPLER EMPTYING DRUM  
 CONTENTS INTO BULKING CHAMBER.  
 DATE/TIME: 05-02-90/1430  
 PHOTOGRAPHER: N. KUMARANAYAGAM *NK*  
 FILM: 35MM, ISO 200

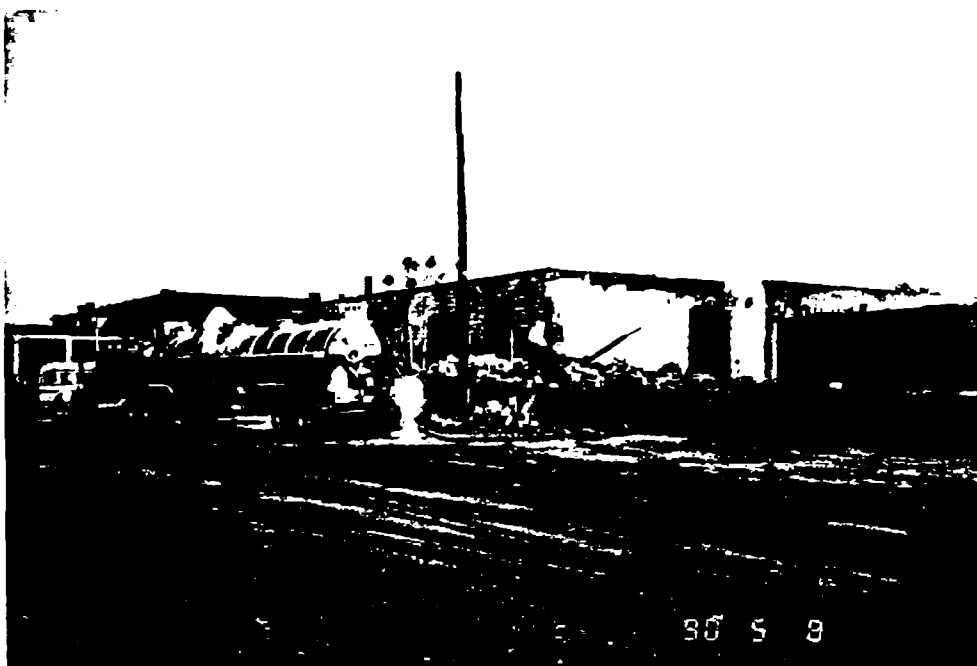
PHOTO: 24  
 SITE NAME: MORRIS PAINT, EAST ST. LOUIS, ILLINOIS  
 DESCRIPTION: CONTENTS OF BULKING CHAMBER BEING PUMPED INTO  
 VACUUM TANKER TRUCK  
 DATE/TIME: 05-08-90/1000  
 PHOTOGRAPHER: N. KUMARANAYAGAM *NK*  
 FILM: 35MM, ISO 200

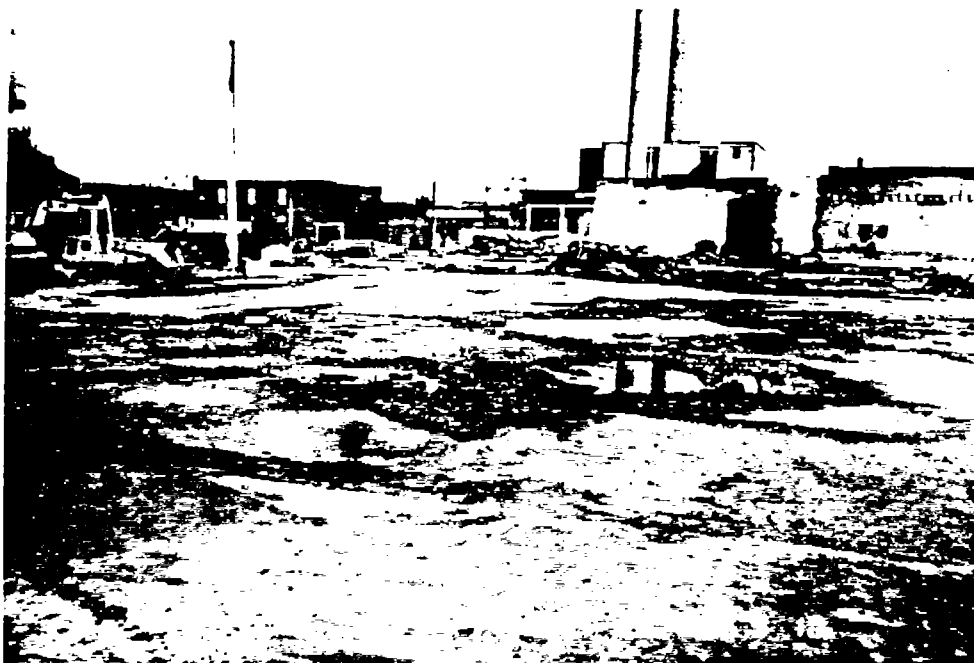
PHOTO: 25  
 SITE NAME: MORRIS PAINT, EAST ST. LOUIS, ILLINOIS  
 DESCRIPTION: DOCK AREA AFTER REMOVAL OF ALL HAZARDOUS  
 MATERIALS LOOKING WEST  
 DATE/TIME: 05-10-90/1120  
 PHOTOGRAPHER: N. KUMARANAYAGAM *NK*  
 FILM: 35MM, ISO 200

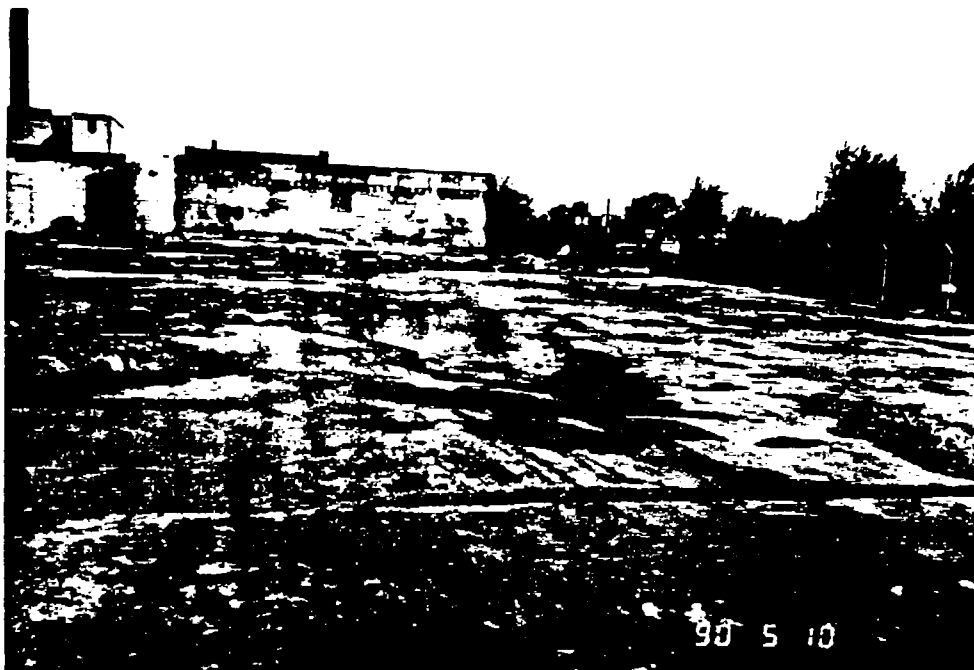
PHOTO: 26  
 SITE NAME: MORRIS PAINT, EAST ST. LOUIS, ILLINOIS  
 DESCRIPTION: DOCK AREA AFTER REMOVAL OF ALL HAZARDOUS  
 MATERIALS LOOKING NORTHWEST  
 DATE/TIME: 05-10-90/1115  
 PHOTOGRAPHER: N. KUMARANAYAGAM *NK*  
 FILM: 35MM, ISO 200

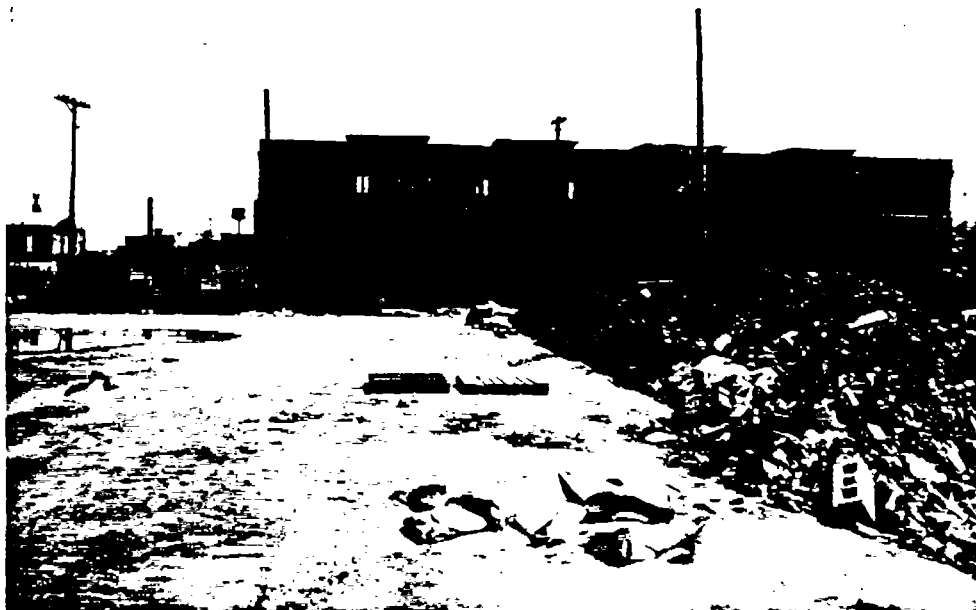
PHOTO: 27  
 SITE NAME: MORRIS PAINT, EAST ST. LOUIS, ILLINOIS  
 DESCRIPTION: DOCK AREA AND FORMER WAREHOUSE AREA AFTER  
 REMOVAL OF ALL HAZARDOUS MATERIALS LOOKING  
 SOUTHEAST  
 DATE/TIME: 05-11-90/1345  
 PHOTOGRAPHER: N. KUMARANAYAGAM *N.K.*  
 FILM: 35MM, ISO 200

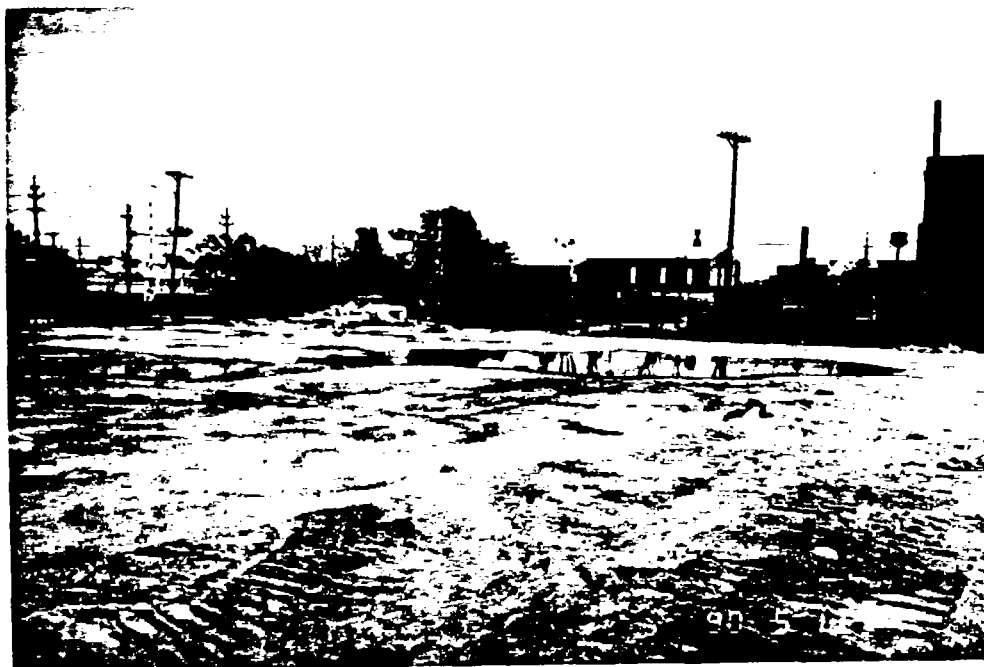
PHOTO: 28  
 SITE NAME: MORRIS PAINT, EAST ST. LOUIS, ILLINOIS  
 DESCRIPTION: FORMER WAREHOUSE AREA AFTER REMOVAL OF ALL  
 HAZARDOUS MATERIALS LOOKING EAST  
 DATE/TIME: 05-11-90/1400  
 PHOTOGRAPHER: N. KUMARANAYAGAM *N.K.*  
 FILM: 35MM, ISO 200
